October 26, 2023

Complaint and Demand For Remediation of Darby Creek

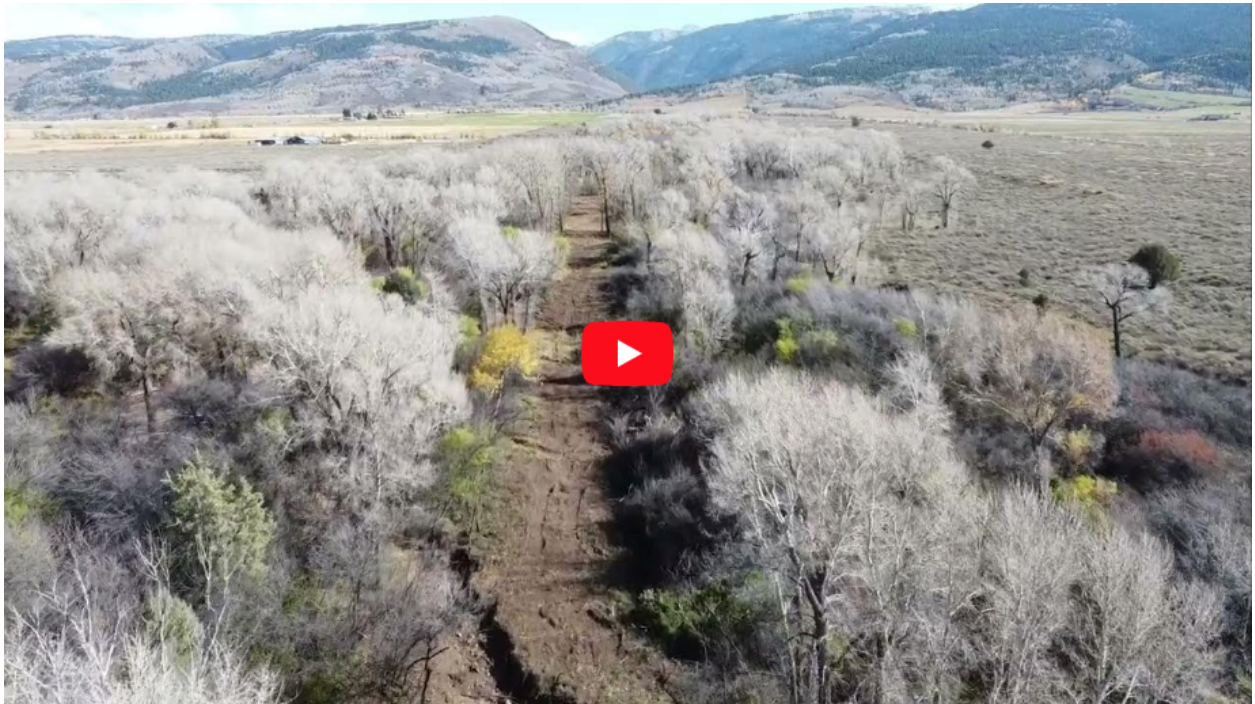
Click image to view drone footage of Nagel's damage to Darby Creek corridor and creekbed.
Credit Brad Boner / JH News and Guide

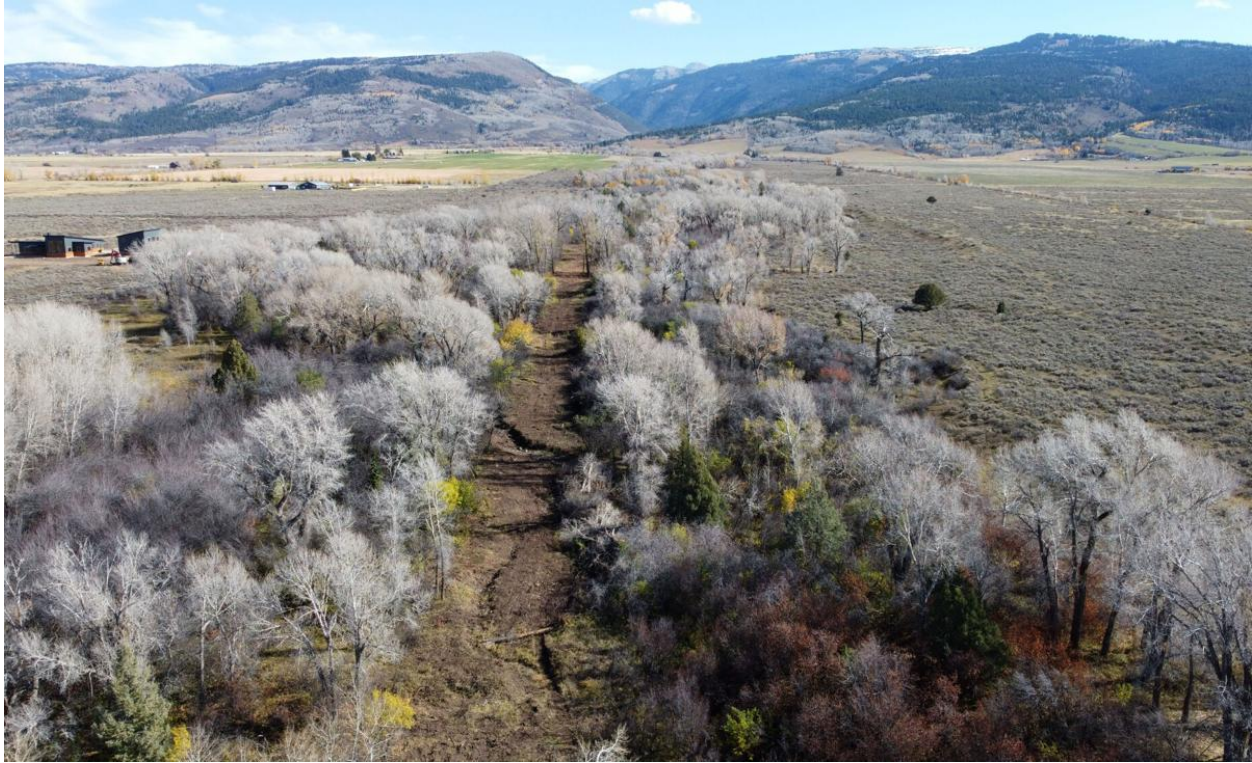
Drone footage of one section of Nagel's damage to Darby Creek corridor and creekbed.
Credit Brad Boner / JH News and Guide

Based on visual observation, Nagel has completely disturbed and reshaped over 100 feet of stream channel, filled-in stream beds with sediment, and disturbed an additional 150ft of stream channel and stream banks as he crossed Darby Creek's stream channels in multiple locations. He has removed nearly 3 acres of critical riparian vegetation from streambanks and the floodplain and dozens of truck loads of cottonwoods and woody vegetation are currently piled-up on the floodplain within the OHWM.

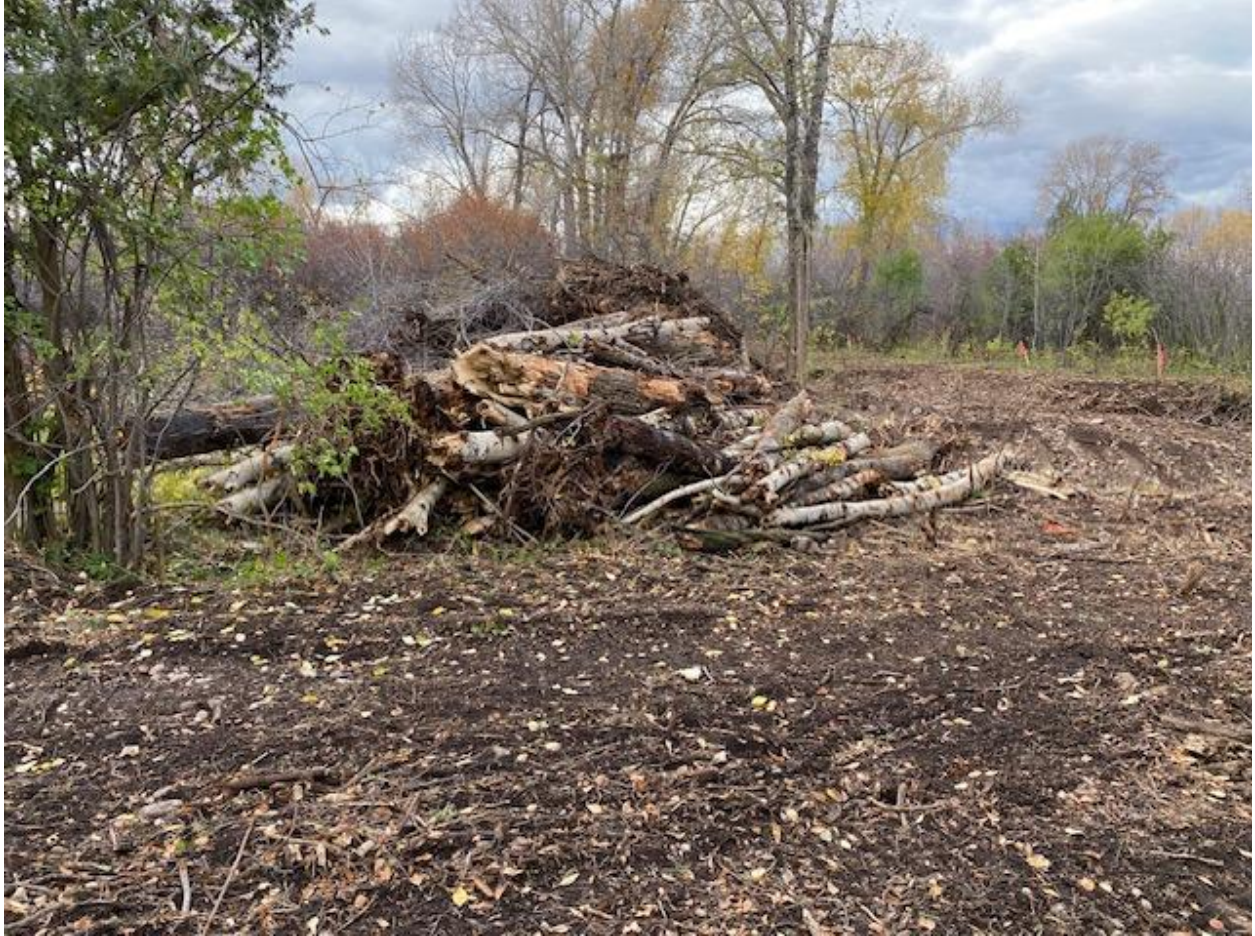
Logged cottonwood trees and brush piled up in several places along the Darby floodplain, abutting the creek. Also note sediment piles in the background.

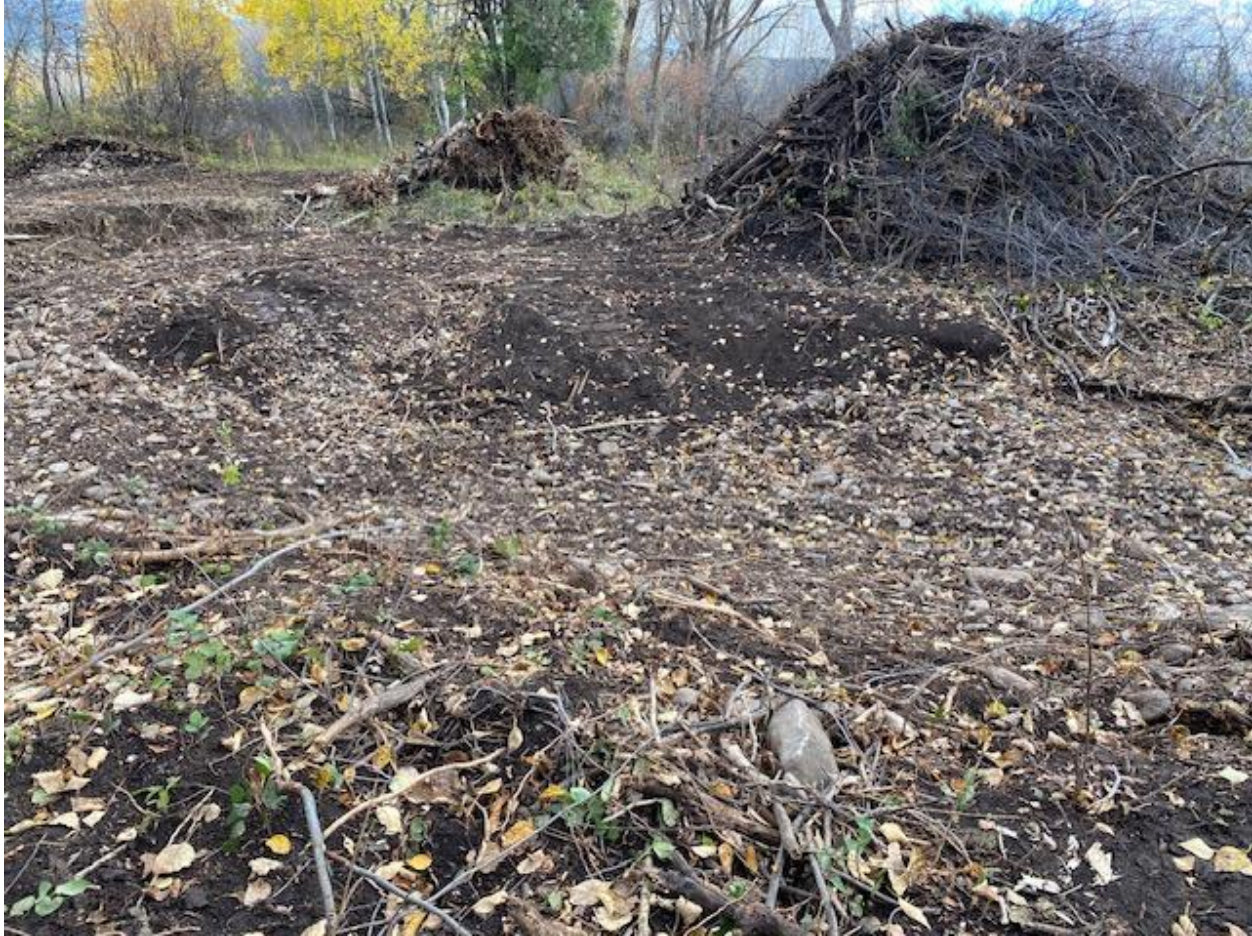
Where Nagel reshaped and crossed stream channels and stream banks, he has discharged an estimated 60 tons of sediment. Where he has reshaped the channel and disturbed stream banks he has dredged an estimated 40 tons of sediment which can be seen stock-piled on the floodplain within the OHWM.

Sediment spread over the original stream channel. Note stream bed cobble is now buried.

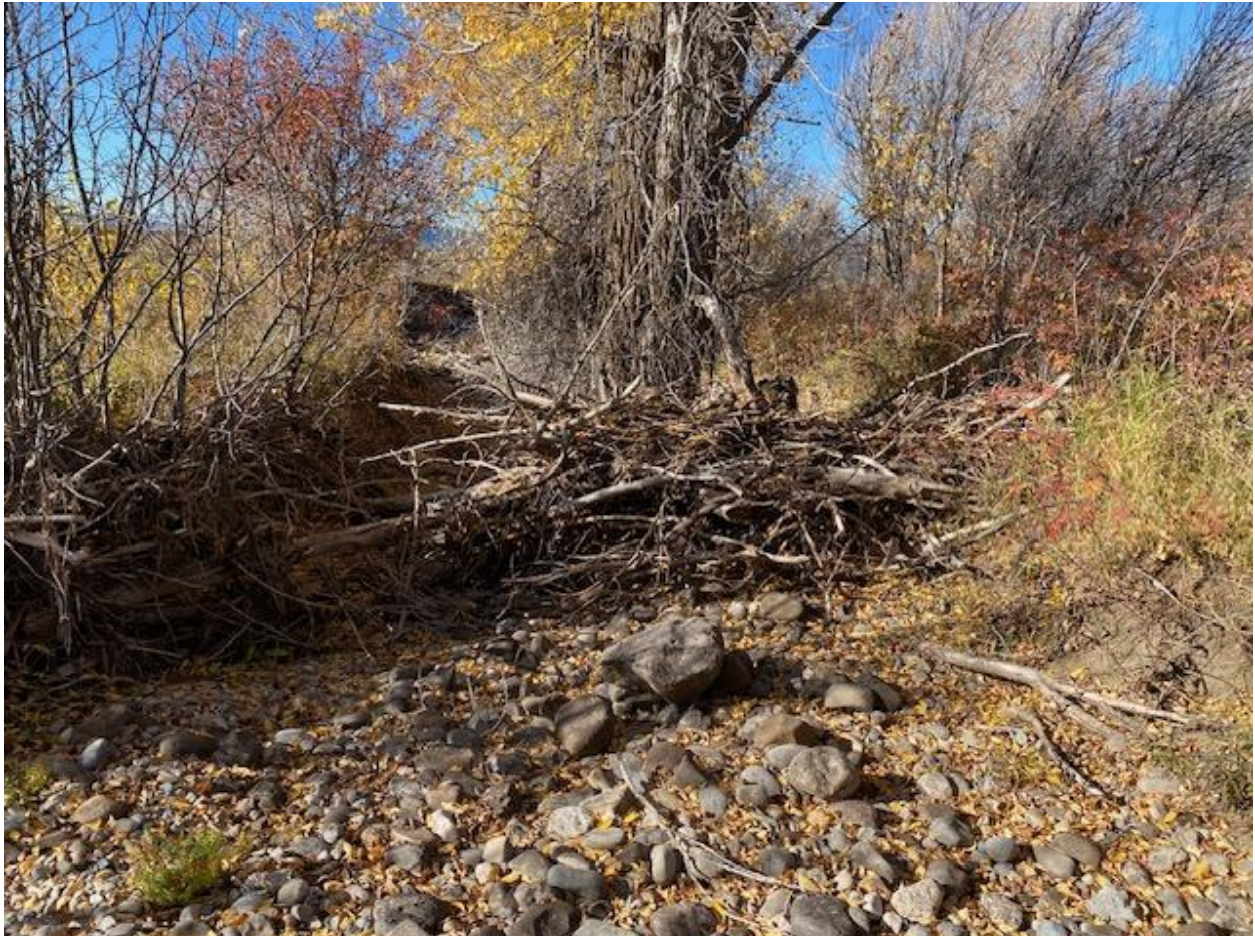
The Nagel section of Darby Creek sits on an alluvial fan. As such, **the Nagel section is especially prone to avulsion events**, which occur when a disturbance such as a newly formed debris jams or excessive sediment deposition causes the creek to suddenly cut out new channels or to start flowing in old remnant channels which are located across the alluvial fan. Avulsion events often occur after dredging and/or vegetation disturbances. Even a small amount of debris caught in a fence across the creek can block the channel and send flood waters in a completely new and unpredictable direction.

Note the debris caught in front of the single tree pictured above. Now, imagine what a dozen fences will capture. This will likely lead to avulsion events since the adjacent banks and floodplain no longer have vegetation protection. Also note the cobble substrate.
