## Complaint and Demand For Permit Administration

October 20, 2023

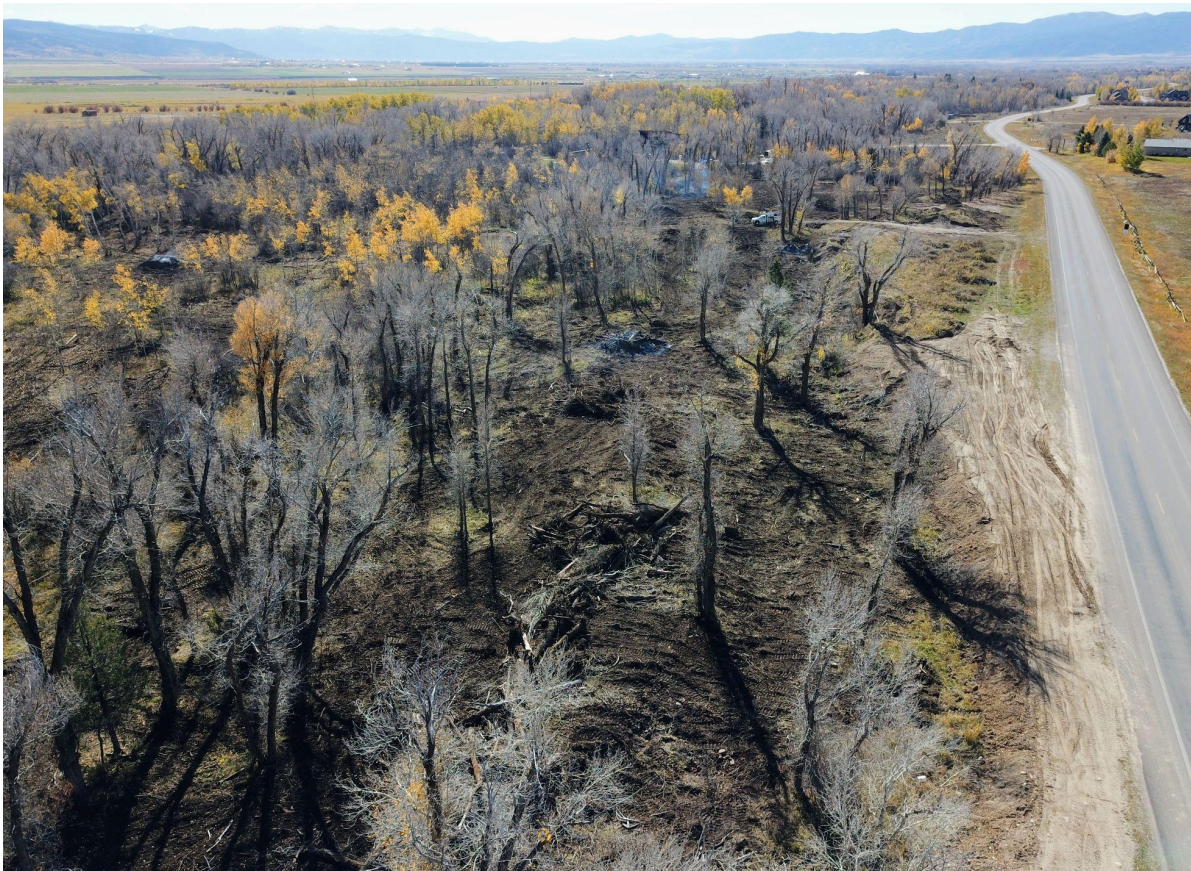
**Pictured above:** October 17, 2023 drone photo showing only a portion of the logging and clearing recently done on the Rouns property. [Click here to view more drone footage.](#)

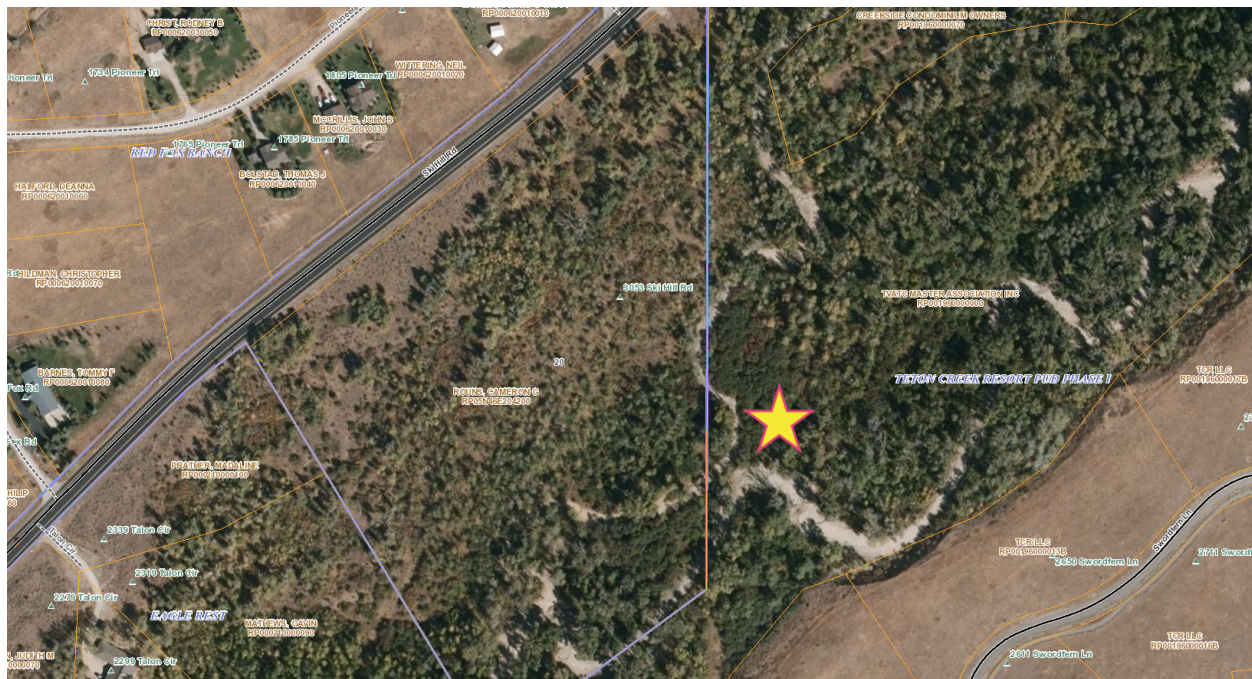
On October 18, 2023, Valley Advocates For Responsible Development staff attorney Anna Trentadue walked the northern border of the property utilizing the Teton Creek Resort pathways system, and viewed the destruction from the location marked on the photo below.

Teton County, Idaho GIS screenshot of Rouns' property at center. Viewpoint is marked with a star.

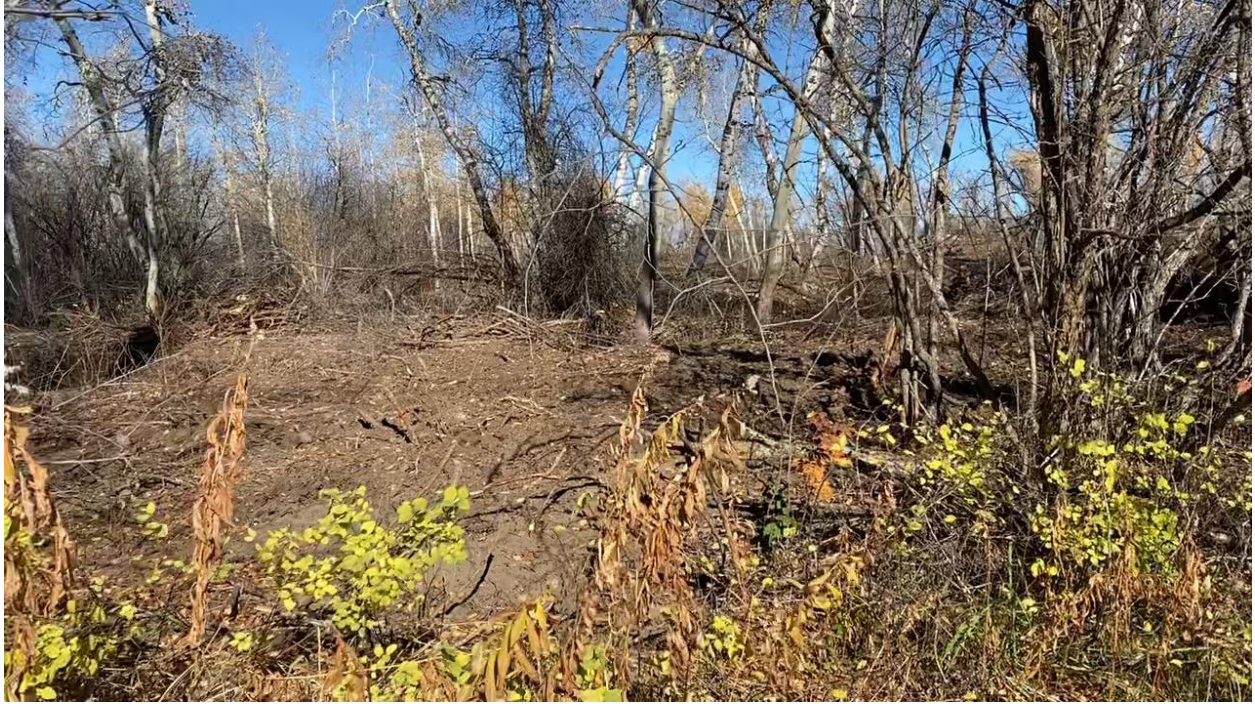
According to Lien's professional assessment, it appears that several acres of critical floodplain vegetation has been removed and vegetation near stream banks has also been removed - all within the OHWM.

Photo taken by Mike Lien while standing in Teton Creek, which shows vegetation stripped up to the edge of the creek channel. October 19, 2023

It appears that extensive grading of the Effective Floodplain and also within the Floodway may also have occurred. **It also appears that Rouns has removed large swaths of critical vegetation within the ordinary high water mark which includes vegetation along the banks of Teton Creek and within the floodplain of Teton Creek.** This volume of removed material must be quantified.

1. Rouns must apply for necessary permits from Teton County, Idaho Department of Water Resources and the Army Corps of Engineers before proceeding with any more work on Teton Creek to determine if their proposed activities are allowed, and to insure that they do not inadvertently cause potentially catastrophic damage to Teton Creek and adjacent properties.

2. Rouns must submit a complete floodplain permit application that details the following
  - a. What vegetation has been removed. This volume must be quantified.

5. Rouns must submit a complete application for a Grading and Erosion Control Permit, including a remediation plan with an engineer's certification, showing no stream or offsite damage during runoff and flood events.

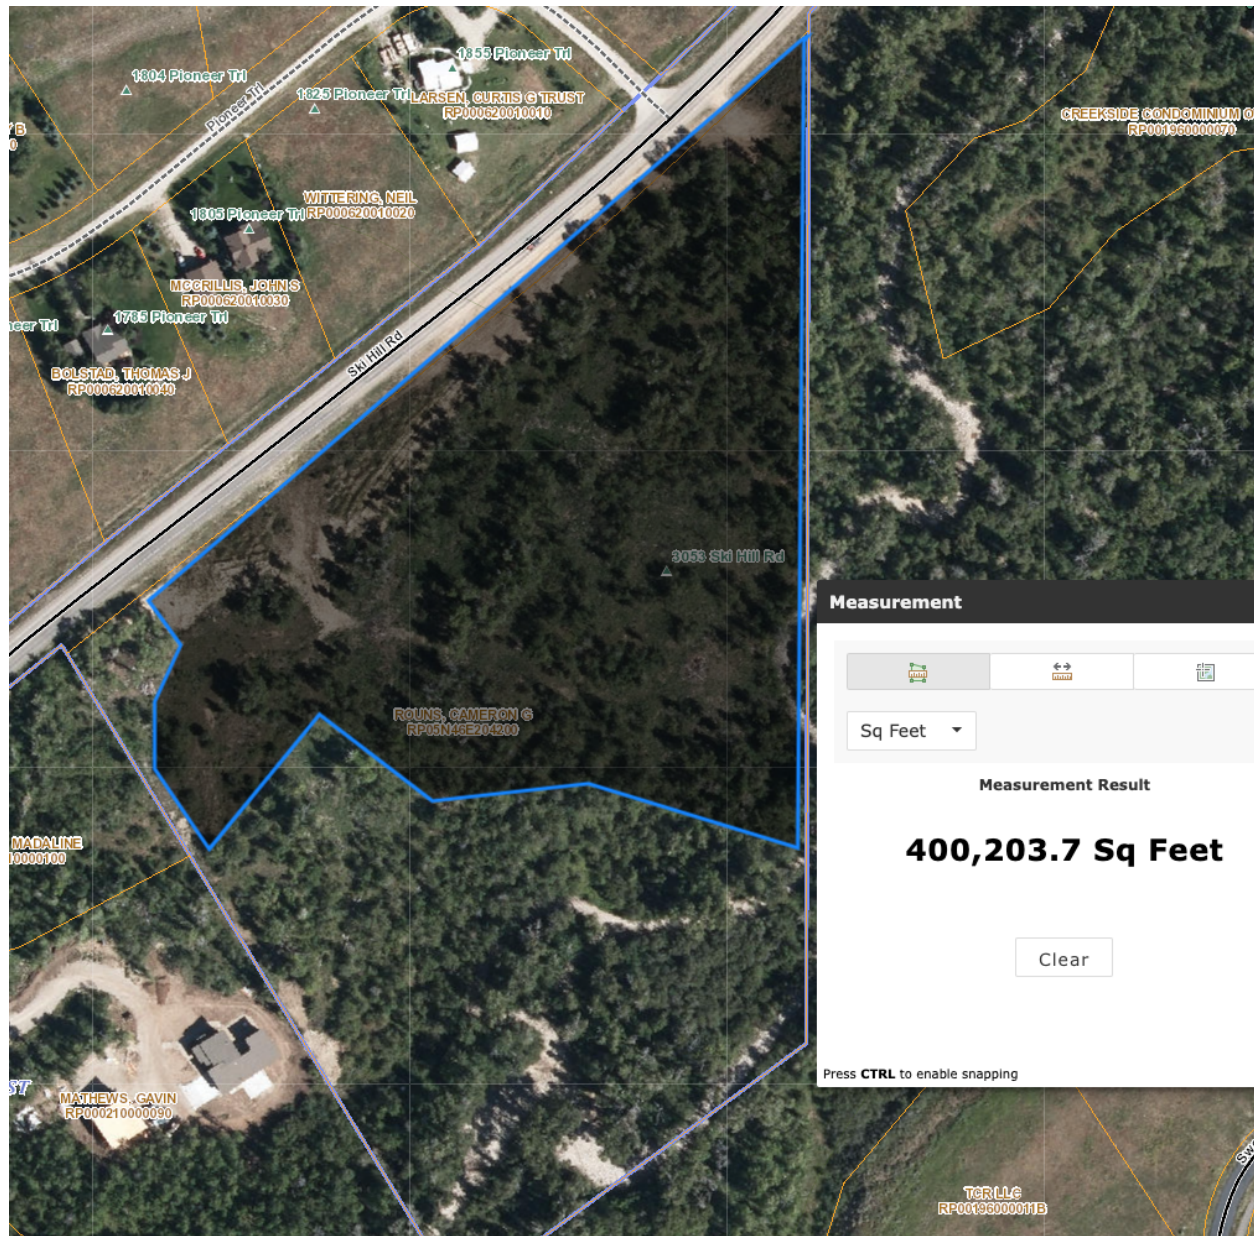
A baseline estimate of the disturbed area, indicates approximately 400,000SF of land has been disturbed, or roughly 9.1 acres. See image on the following page, below.

Preliminary estimate of the disturbed areas on Rouns property.

**Indeed the disturbed area could easily be larger than this initial estimate.** In order to properly evaluate the potential hazards and risks posed by Roun’s clearing of the property, it is critical to have a professional assessment of the changed conditions including: quantification of the disturbed area, quantification of vegetation lost, and predictions for sediment discharges into Teton Creek with the snowmelt and spring runoff next year.
